Manhole Inspection Summary

Manhole # S35EE1001MH

Location Address: **107 SAINT MARTINS RD**

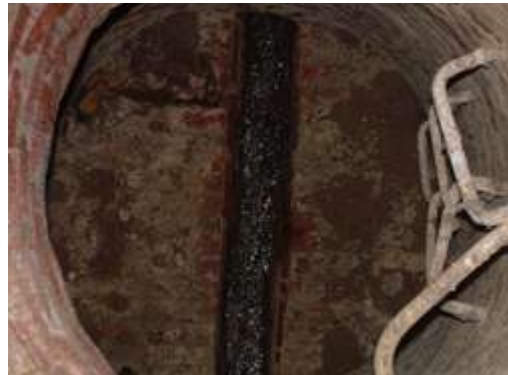
Top View

Condition: ☐ Sound ☐ Cracked ☒ **Root Intrusion** ☐ Loose Brick ☐ Deteriorated

Infiltration: ☐ None ☐ Joint ☐ Cracks ☐ Mortar ☒ **Roots** ☒ **Wall**

Barrel root intrusion and infiltration. Bench debris.

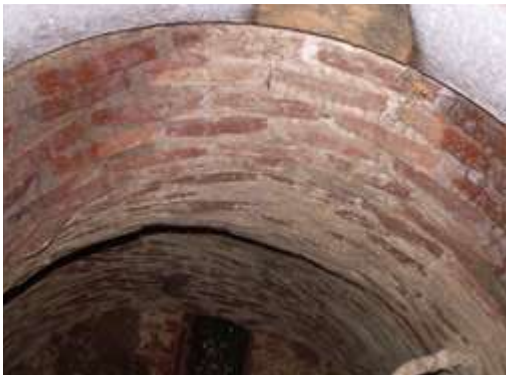
Defect

Infiltration: ☐ None ☒ **Joint** ☐ Cracks ☐ Mortar ☐ Roots ☒ **Wall**

Infiltration: ☐ None ☐ Joint ☐ Cracks ☐ Mortar ☐ Roots ☒ **Wall**

Adjustment, Corbel and Barrel infiltration.

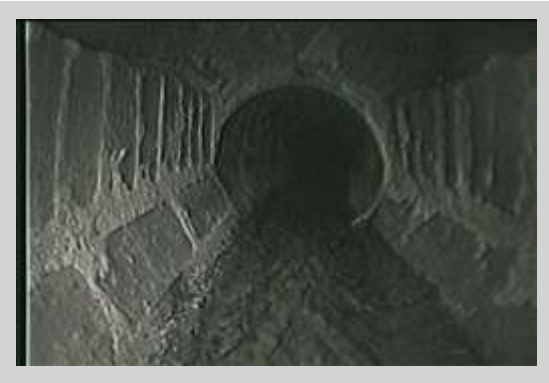
Pipe Out @ 12 O'Clock

Infiltration: **None** Pipe Seal Cond: **Unknown**

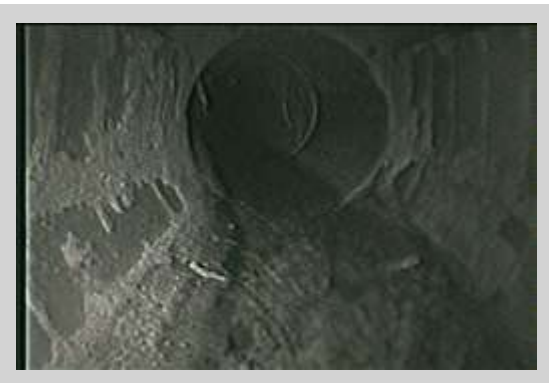
Pipe In @ 6 O'Clock

Infiltration: **None** Pipe Seal Cond: **Unknown**
